**Sterling Fluid Systems (USA), Inc.**

**INB SM1-203R**

**Subject:** Dezincification of Silicon Bronze Impellers - (Peerless Material Code 449)

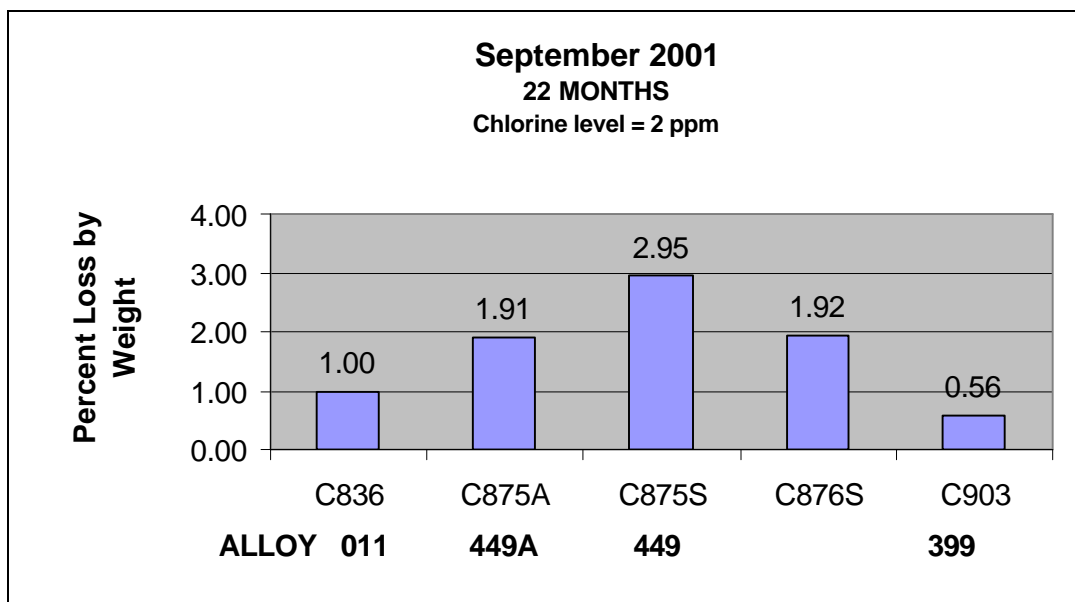
Peerless has been working with a number of end-users for several years addressing Dezincification applications. During 2001 Peerless and one of our major impeller suppliers were involved with several test set-ups hoping that we could define a specific chlorine concentration level (parts per million, ppm) at which we would recommend making an alloy change. Running and impingement tests were/are conducted with chlorine concentrations of 1,2,3,5 and 7 ppm comparing several alloys in each concentration. There was no definitive chlorine concentration level at which we could clearly recommend changing our standard impeller alloy. The following bar graph shows a comparison of product loss for several tested alloys in a chlorine concentration of 2 ppm. This was a typical comparison for all of the chlorine concentrations noted above, but more product loss was evident with higher concentrations of chlorine.

Our major supplier, through stricter quality control, has minimized the percentage of zinc in the impellers we are furnished (from 16% to 12%) and still meet the C87500 specification. This is noted as Peerless material code 449A (C875A) in the bar graph.

Copper Development Association	C836	C875A	C875S	C876S	C903
Peerless Internal Material Code	011	449A	449		399
